Issue 20, April 2014

2011 Hawkes Bay landslips: A geotechnical perspective

S R Soysa

Tonkin & Taylor Ltd, Auckland, NZ

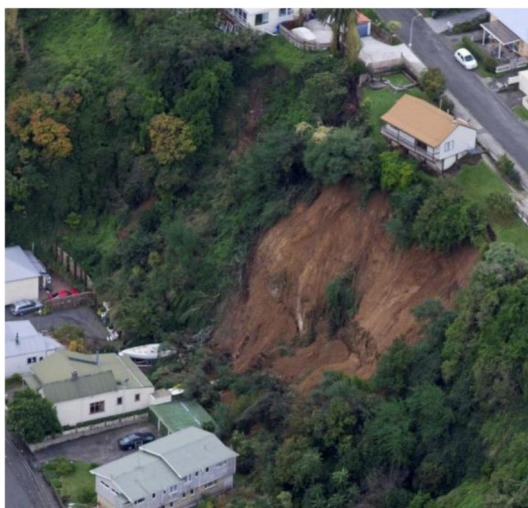
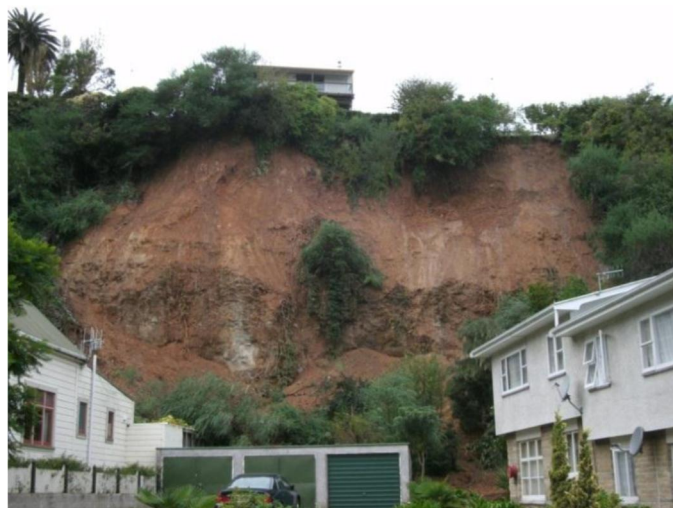
A large translational landslip occurred at the top of a slope approximately 30m high and 55° steep at 22 Guys Hill Road. As shown in Figures 1 and 2 below, this caused substantial evacuation of land from the property, causing inundation and damage to the properties below at 19 Chaucer Road. Due to the precariously positioned nature of the dwellings above and below the landslip, these properties were immediately evacuated following the event. The property at 22 Guys Hill Road was ultimately removed because the required solution to ensure a safe and stable building platform (and minimising imminent risk) was deemed to be too expensive and difficult.

Figure 1: 22 Guys Hill Road Landslip

Figure 2: 22 Guys Hill Road Landslip

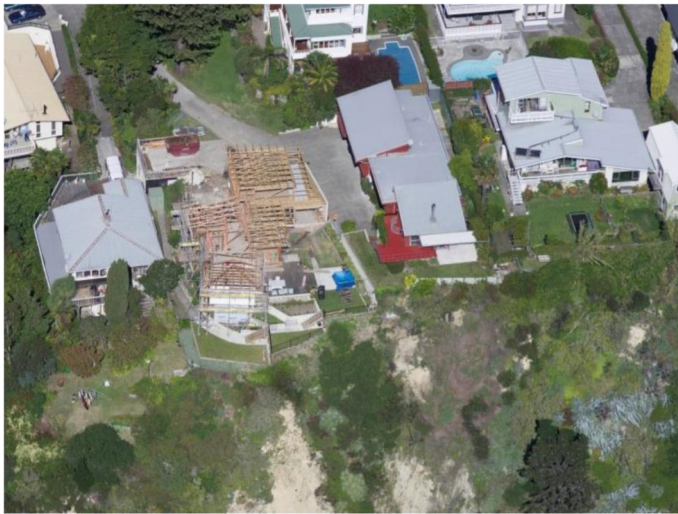
Figure 3: Karaka Road slopes prior to failure

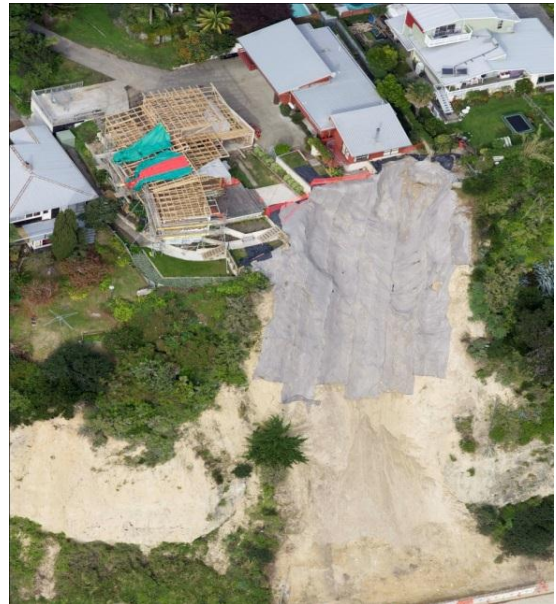
Another large translational landslip occurred at the top of the slopes supporting 22A and B Karaka Road and 24A Seapoint Road above Breakwater Road at the northern end of Napier Hill. As shown in Figures 3 and 4 below, this caused significant retreat of the cliff face supporting these residential dwellings. At the height of the storm, 7 properties were evacuated by civil defence. Inundation of Breakwater Road by this landslip resulting in this major road being temporarily unpassable until the debris was cleared and traffic management was required numerous weeks after this event. As this landslip headscarp traversed three separate properties, the solution ultimately comprised a large 50m long, 15m deep reinforced concrete retaining wall with ground anchors.

Figure 4: Karaka Road landslip

The existing stormwater capacity on Napier is fully allocated and the majority of the older properties on Napier Hill discharge stormwater run-off directly into the ground whilst any new dwellings on Napier Hill discharge stormwater to the kerb. Due to this, a high percentage of the EQC claims on Napier Hill can be attributed to poor stormwater management.

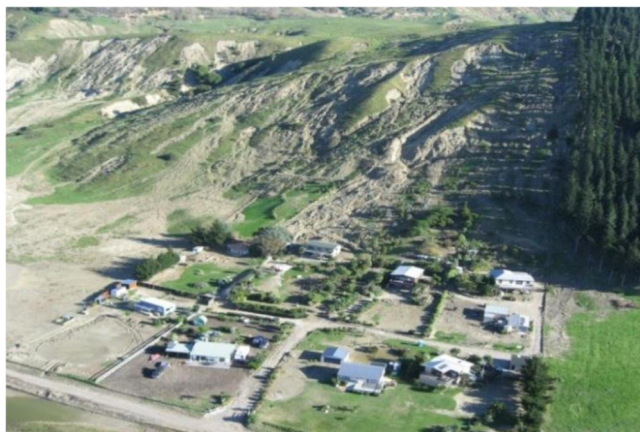
Figure 5: Shallow debris flow behind Waitangi Road Properties

The authors company were involved in constructing a protective bund around the property at 145 Waitangi Road, to reduce the imminent risk of damage to property and life from a future event of this nature. This 3m high bund was constructed using compacted locally sourced material and tested for 98% of maximum dry density. We understand that a group of residents further along Waitangi Road have combined their EQC payouts to construct a protective bund to safeguard their properties from debris inundations.

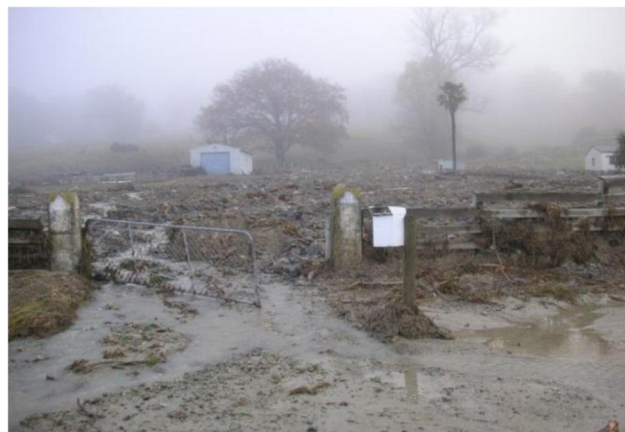
Figure 6: Severe debris inundation of fields and roads in Waimarama

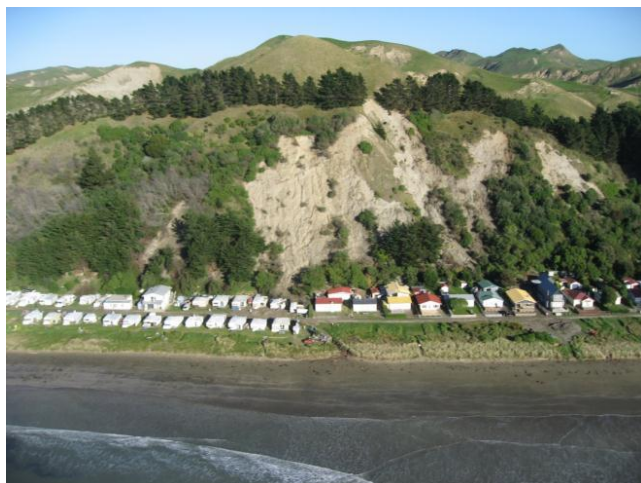
Following this intense rainfall and small seismic event, significant damage was caused to properties and lifelines directly in this area of Pourerere Beach by the land inundation that occurred as a result of the landslips. Approximately 57 EQC landslip claims were lodged and these landslips were a combination of deep seated and translational failures. We consider the rare event of elevated ground water conditions being combined with a seismic event to be the cause of the large-scale slope failures with significant debris inundation of dwellings.

Figure 7: Landslips above Pourerere Beach settlement

An on-going risk currently exists of large amounts of failed material on the slopes above the township. This will require significant stabilisation measures as well and it would be prudent for an early warning system to be installed to protect the lives, properties and lifelines below.

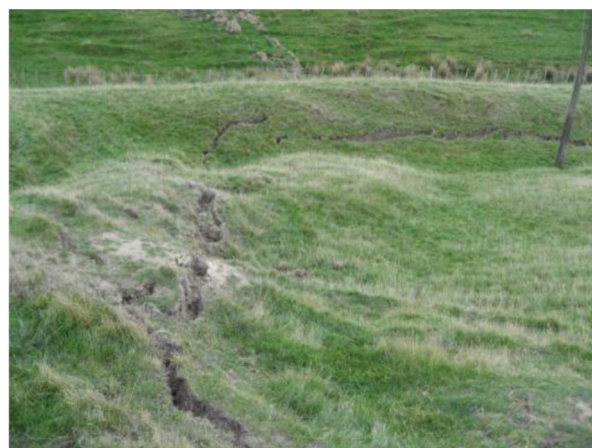
Figure 8: Large tension crack in hills above Pourerere Beach

Following the landslips, the hillside above the dwellings was assessed to be unstable, with large tension cracks appearing behind the existing landslide headscarps. The authors company led regional study of this area led to the conclusions that 27 of the 33 residential dwellings and 50% of the camp ground site in this area of Pourerere Beach were considered to be at imminent risk and at “total loss” in accordance with EQC provisions. This was due to these dwellings being located directly below (and within the inundation paths) the unstable sections of the slope (as illustrated in Figure 9) that are expected to fail in the short term. As the dwellings were located at close proximity to the base of the slope, a debris barrier could not be considered due to the failed land being owned by others, EQC cannot remediate land not owned by the claimant.

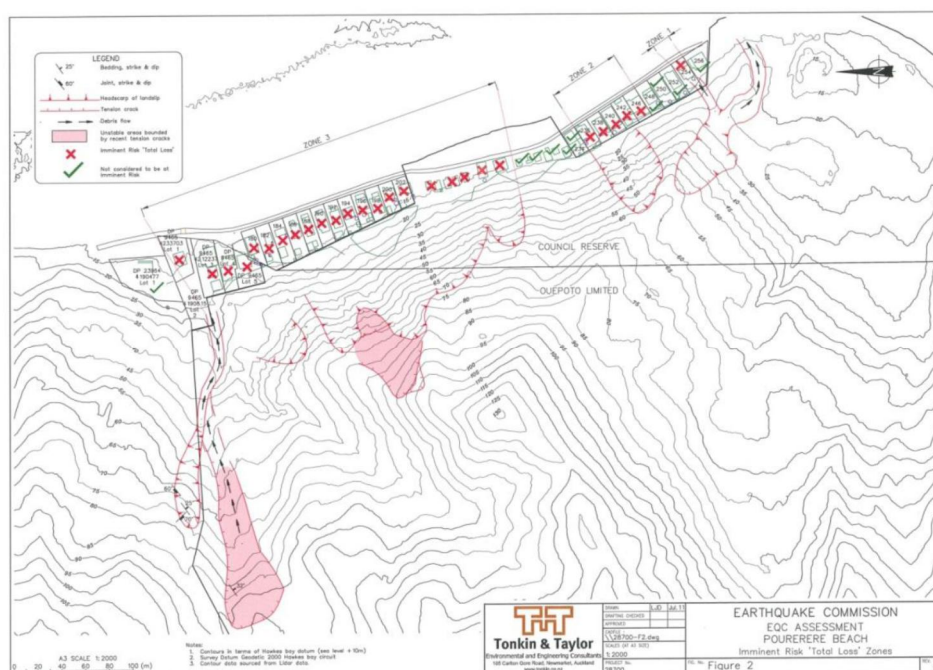
Figure 9: The Properties at Pourerere Beach that were classed at imminent risk – Total Loss for the EQC

For the properties that were not deemed at total loss, an early warning system was implemented by the CHBDC and operated by the local fire service to help safeguard lives during periods where the slopes are deemed to be unstable. The local residents have been notified of this warning system, including evacuation procedures following activation of the siren.
