**CETANZ**

# NEWSLETTER

Issue 32

June 15, 2018 | ISSUE 32

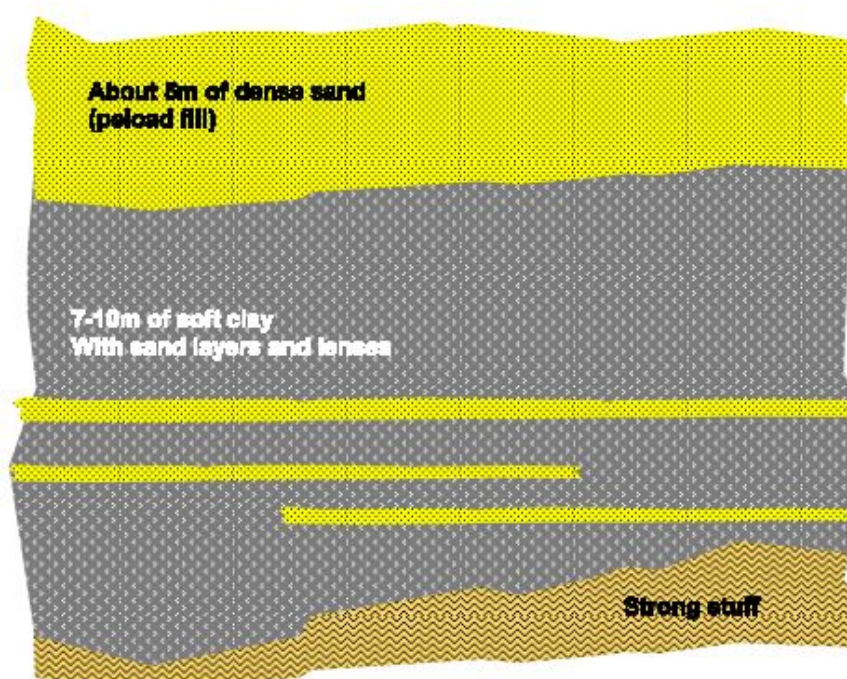
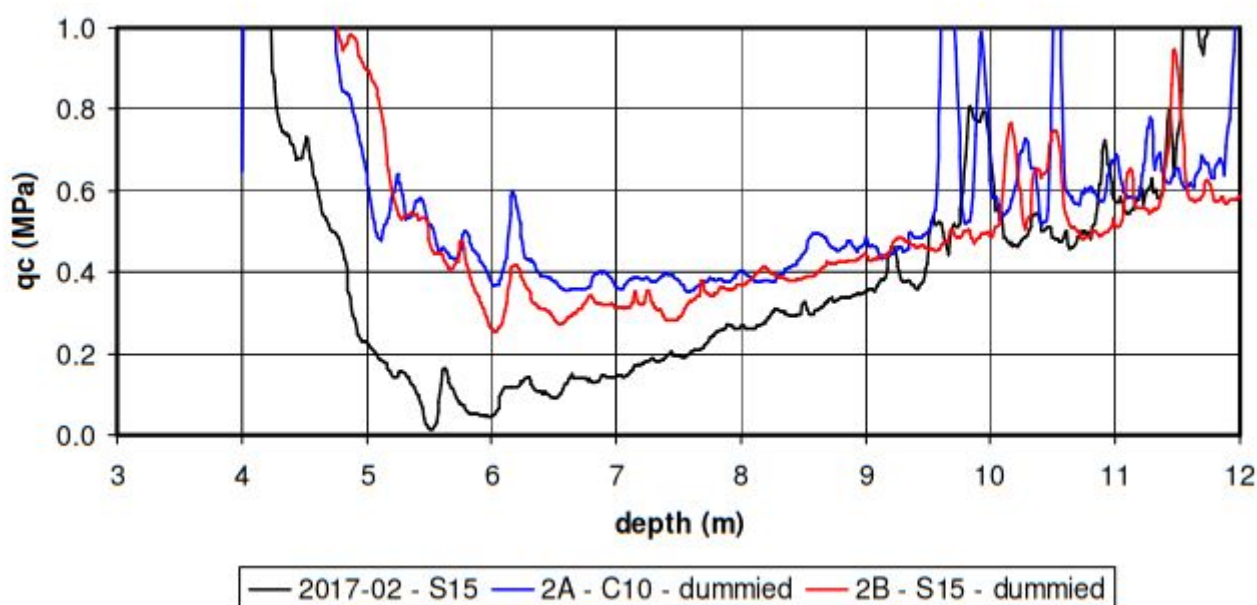
## CPT COMPARISONS - LOCATION XXXX

1. Test 02 was pushed using an S-15 cone. It was pushed from surface, through about 4m of sand.
2. Test 2A was pushed using a C-10 cone. It was pushed from 4m depth from the bottom of a dummied hole.
3. Test 2B was pushed using an S-15 cone. It was pushed from 4m depth from the bottom of a dummied hole.

My conclusion from this is that the original push at this site was affected by heating up due to pushing through dense sand. The "errors" due to this became progressively less with depth as the heated cone was cooling down over about 5m of push through the soft clays below the sand.

The strain gauges in all of these cones are temperature-compensated Wheatstone bridges - but it is apparent/obvious that during temperature transition the compensation is ineffective.

Because we were concerned about this, IGS continued on and did some more comparison testing, for our own purposes and education, which is described in the following two pages. This proved that temperature-change effect had been the "elephant in the room" on that project; the cones were heating up as they penetrated the dense sand, then cooled down over a few minutes in the soft layers below that. As they were cooling they were "reading low" – by enough that the errors were very very significant in the qc range that mattered on this job. As an aside, we also noticed that it took longer for the S-15s to stabilise than the C-10s, possibly because there is "a lot more solid metal" inside an S-15.

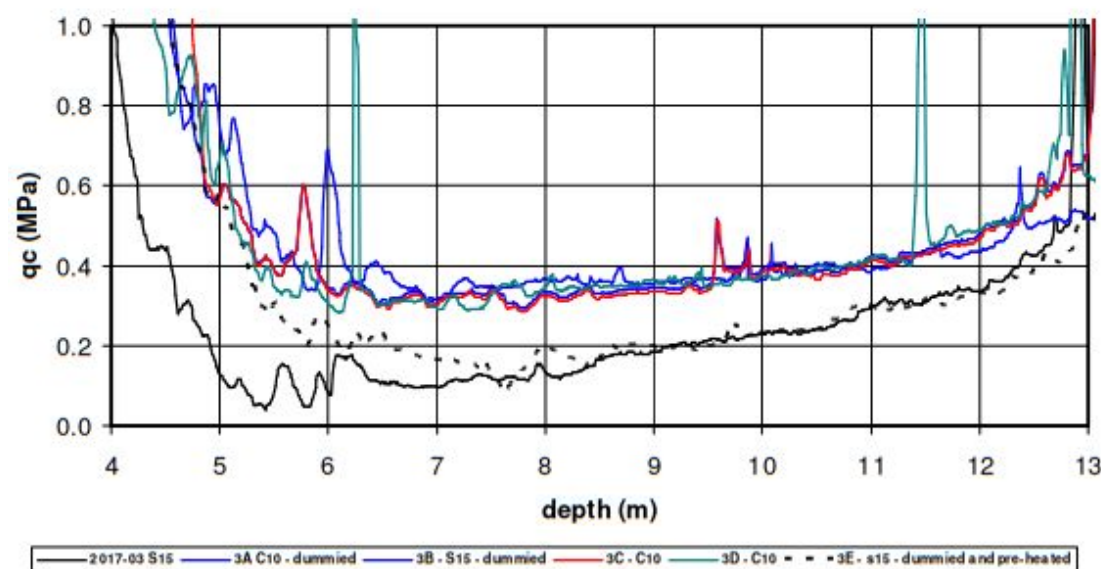
**PORT WEST PRELOAD  
CPT COMPARISONS -  
LOCATION YYYY**

1. Test 03 was pushed using an S-15 cone. It was pushed from surface, through about 4m of sand.
2. Test 3A was pushed using a C-10 cone. It was pushed from 4m depth from the bottom of a dummied hole.
3. Test 3B was pushed using an S-15 cone. It was pushed from 4m depth from the bottom of a dummied hole.
4. Tests 3C & 3D were both pushed using a C-10 cone. They were both pushed from surface, through about 4m of sand.
5. Test 3E was an S-15 cone that had been preheated in near-boiling water before the push. It was pushed from 4m depth from the bottom of a dummied hole.

My conclusion from this is that the original push at this site was affected by heating up due to pushing through dense sand. The "errors" due to this became progressively less with depth as the heated cone was cooling down over about 7m of push into the softer clays below the sand. This effect was confirmed by the final 3E push that had been preheated but then pushed down a dummied hole. This showed very similar behaviour to test 03. This confirmed that temperature shift has been the problem with the original tests. IGS will need to take this more into account on future projects

The strain gauges in all of these cones are temperature-compensated Wheatstone bridges - but it is apparent/obvious that during temperature transition then compensation is ineffective.

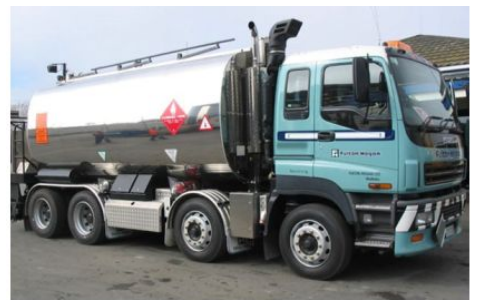
## Bitumen Sprayer Fire

**In the early hours of Sunday 9 April 2017 there was a catastrophic fire in Fulton Hogan's Waikato yard.**

2005 8x4 Multispray® - destroyed (replacement value): \$900,0000  
2013 4x2 first coat Multispray® - damaged: \$400,000  
4 axle bitumen trailer (No 1) - damaged: \$20,000  
3 phase power supply - destroyed: \$10,000  
Other yard and miscellaneous damage: \$20,000  
Lost profitability: \$200,000  
Estimated total damage: \$1.55M

The fire was so destructive that it's been impossible to definitively determine the ignition source. However –  
Three possible causes and their likelihood have emerged:

- Arson - low likelihood
- Electrical fault - medium likelihood

- Self ignition of contaminated insulation - high likelihood

- Always have any leak checked and repaired immediately.
- Check where product may have leaked/spread to within insulation.
- Clean all surfaces and replace any contaminated material, no matter how minor, before replacing with new insulation.
- When cleaning equipment:
  - Always check that the cladding on your unit is intact and waterproof before applying cleaner.
  - Minimise solvent use, minimise quantity used (wipe on, wipe off), and don't force under cladding joints.

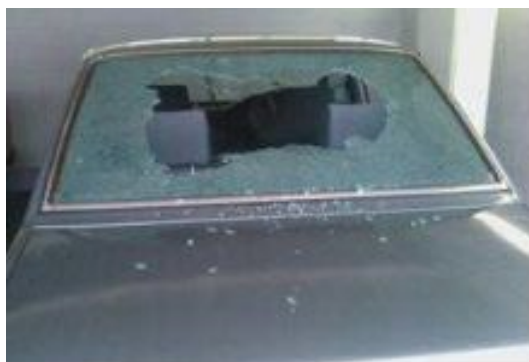
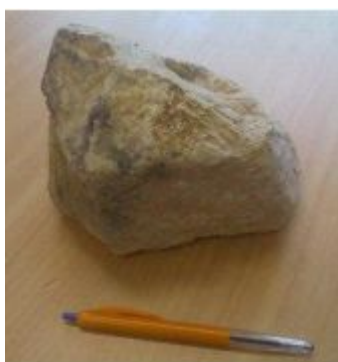
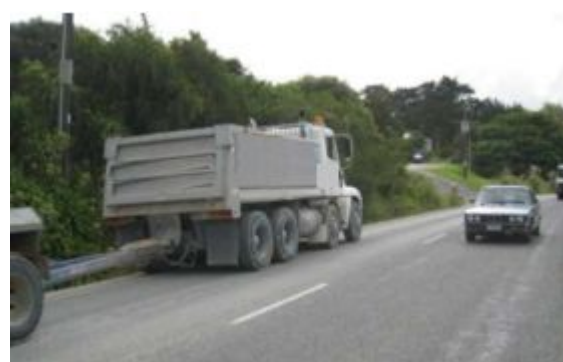
Vehicle travelling on SH1 between Tamahere and Hamilton sustained damage resulting in personal injury to the driver when a football sized rock flicked up and smashed the front windscreen.

Although this incident may not be directly related to the project this has happened previously in our industry and is a significant risk we must manage, as shown in pictures below:

- Rocks lodged in between duals create excessive centrifugal force creating a potential rocket when released.
- Loose items left unmanaged on truck trays and drawbars.

- All trucks must be checked to ensure there are no rocks in between the duals, draw bars are clean and any

loose items are secure prior to exiting project sites and accessing public roads

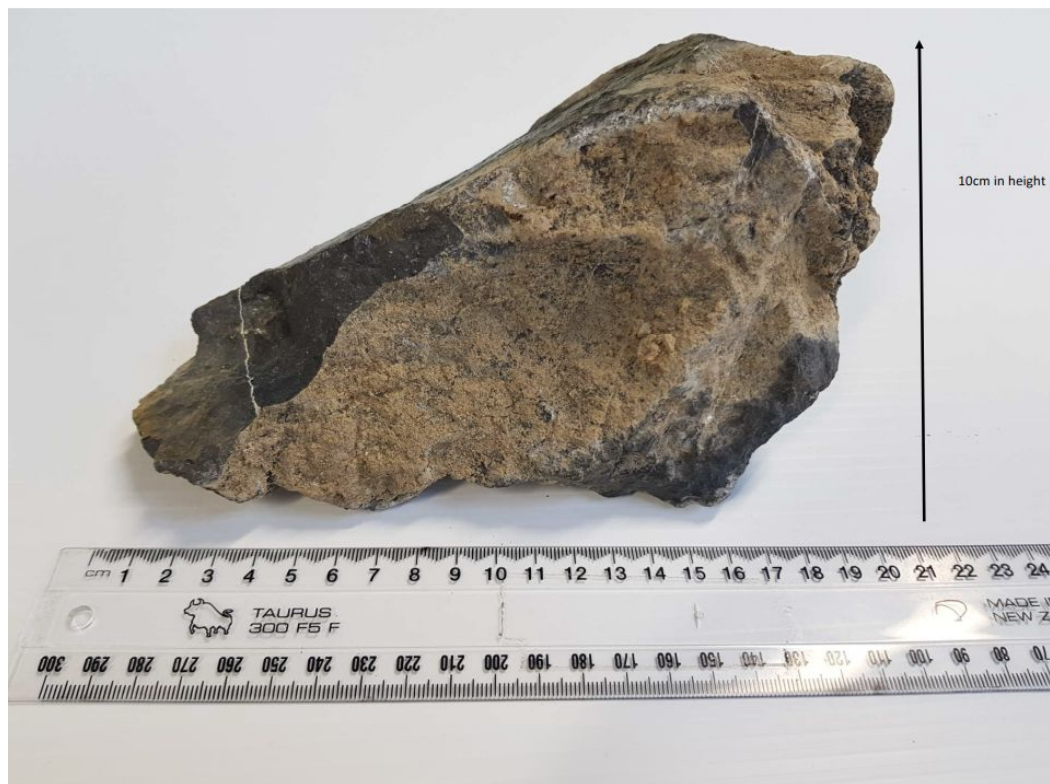
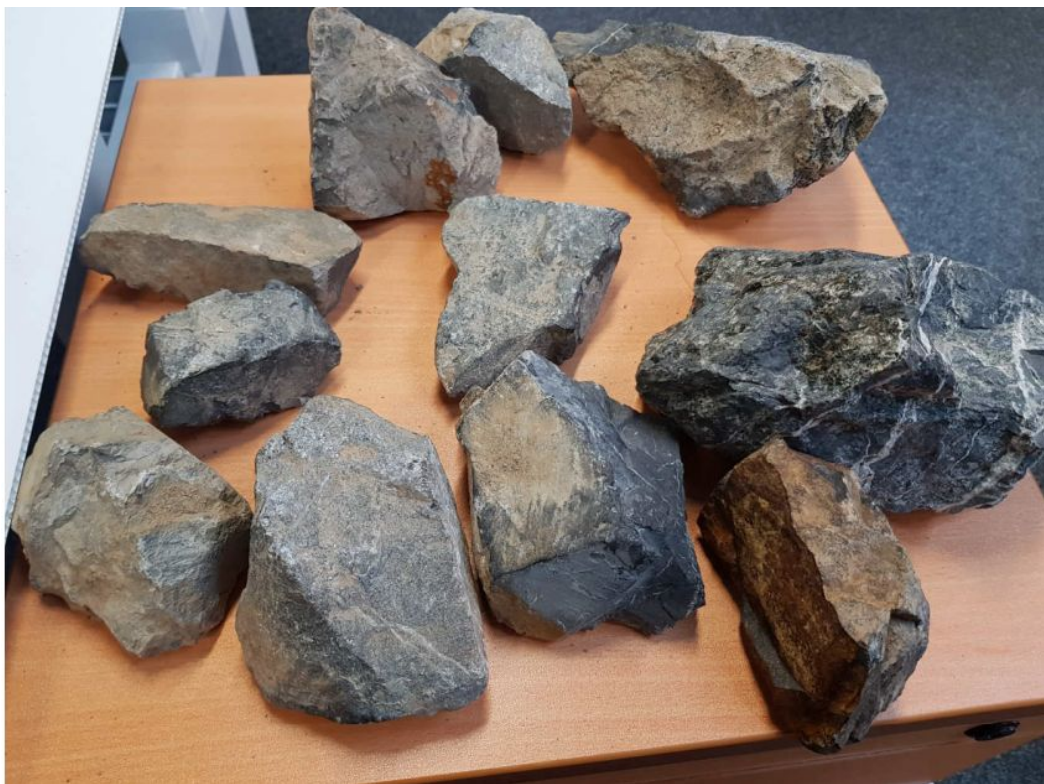
# Samples of Rocks on roads

All these rocks were found on the road near our entranceways today.  
All between 10-20 cm in length and 5-10 cm in height at their longest and highest points
