Safety alert

Roller vs NDM Collision

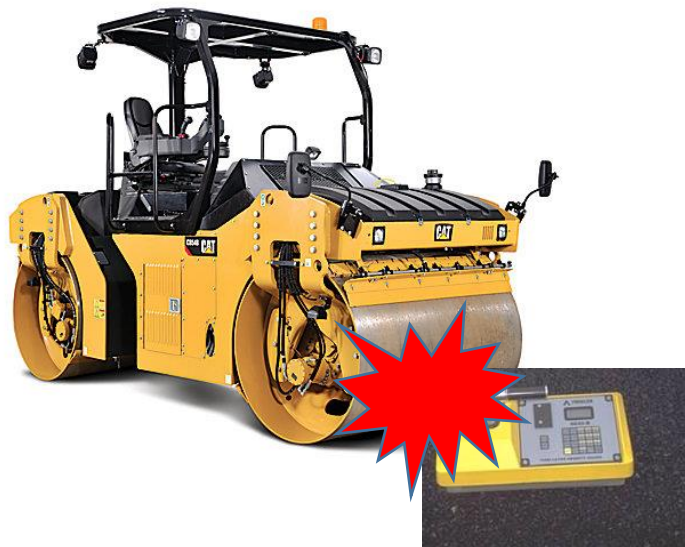
- Technician completed a test and stood by the side of the road to do paperwork
- A roller from distance came back all the way from the end of the mat and pushed the NDM gauge out of the position
- The top of the gauge handle is scraped. The pin is bent slightly

- The roller driver did not see the gauge nor the red flag on the gauge
- Not enough controls around the gauge, e.g., safety zones, barriers

- Complete hazard identification form to identify the hazards on the job site
- Identify the traffic flow and draw a traffic management plan for the job
- Before testing is started, communicate with site supervisor and roller driver with the site hazards and hazards that testing crew brings on site and safety requirements for testing.
- Place physical barriers (cone or trolley) between roller and the gauge at least 5 meters from the gauge
